Avoidance of Ceramic-Substrate-Based LED Chip Cracking Induced by PCB Bending or Flexing

This application note discusses the trends and symptoms observed from failed ceramic-substrate-based LED components in LED luminaires. Cree LED's testing and analysis of such luminaires revealed LEDs that exhibited one or more cracks in the LED chip as well as in the ceramic substrate. It is not the intent of this application note to identify and quantify all the conditions that induce cracks in an LED chip and the underlying

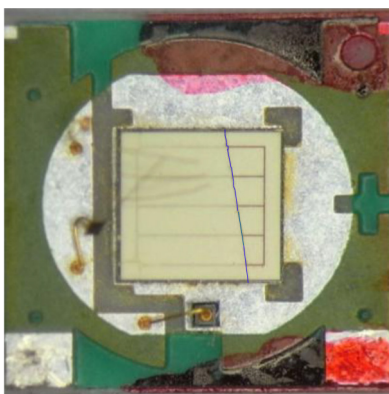
LED chip crack (highlighted in blue) due to PCB bending/flexing

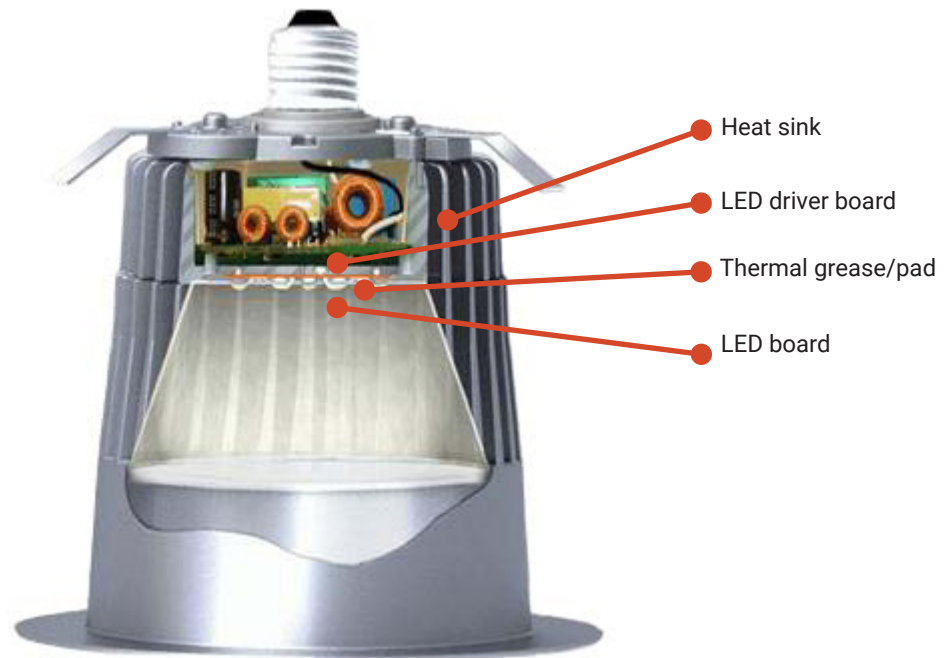
Figure 1: Example LED luminaire

In a typical LED luminaire, the LED board is secured to the aluminum heat sink/housing using one or more metal screws. Thermal grease or a thermal pad is typically applied between the LED board and the aluminum heat sink to help with thermal conduction during luminaire operation. An electronic driver circuit may be included either internal or external to the luminaire depending on the size and design constraints of the luminaire. Figure 1 shows an example of a typical LED luminaire. Figure 2 shows LED boards secured to the underlying heat sink assembly with screws.

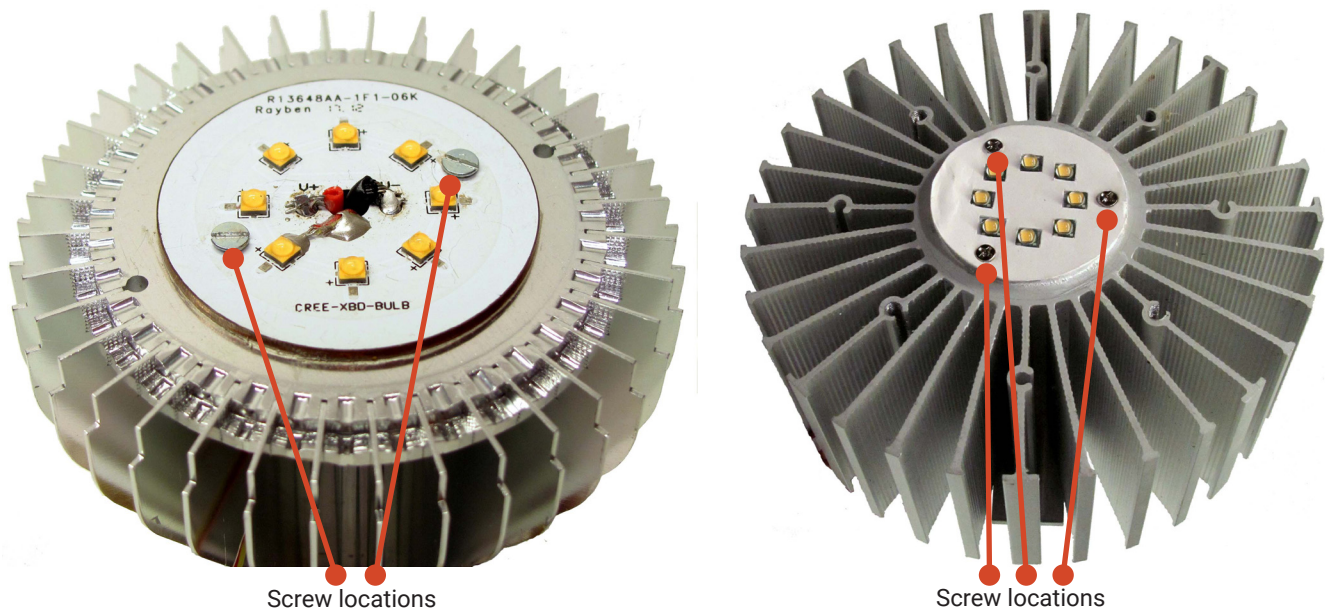
Figure 2: Examples of LED boards attached to a heat sink. Metal screws are typically used in addition to thermal grease/tape to ensure close adhesion to the underlying heat sink assembly.

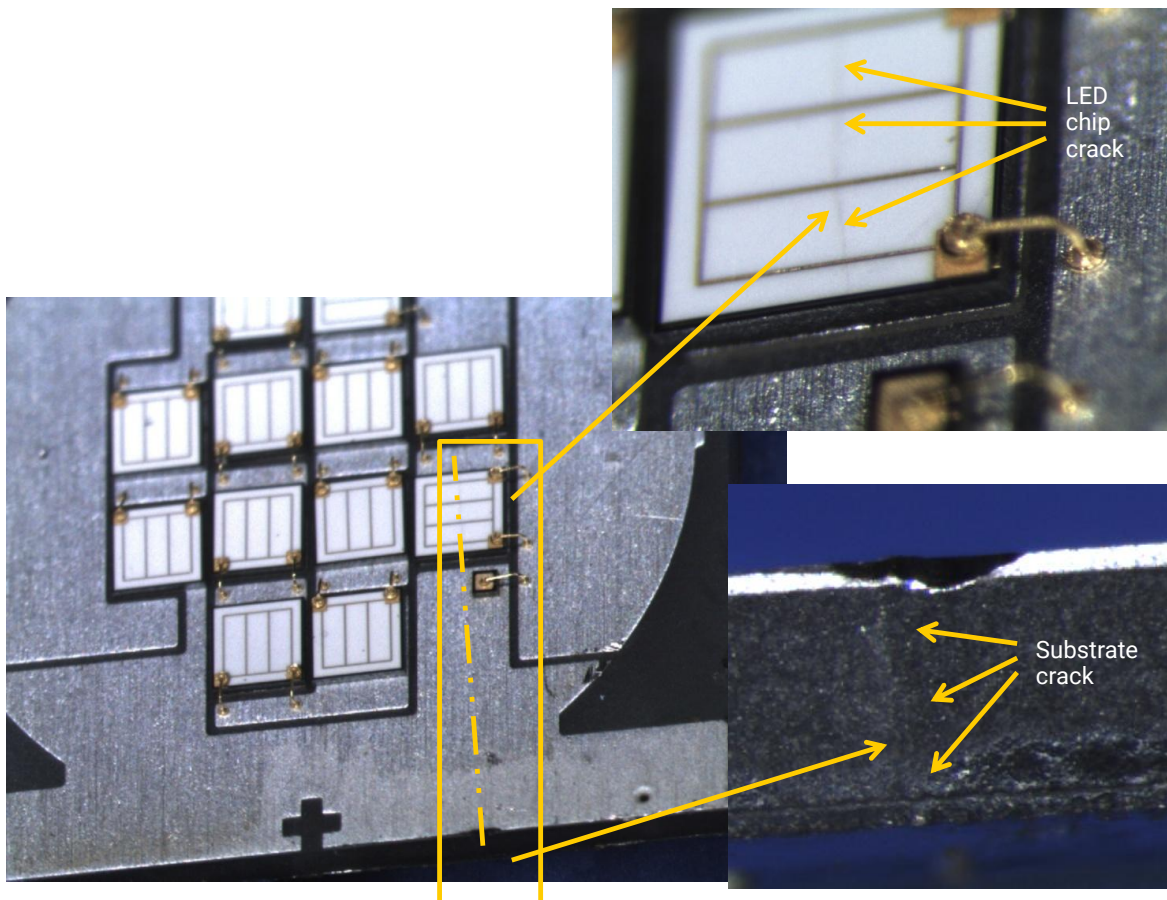
One of the primary failure modes observed in LED chips used in LED luminaires is an LED chip that exhibits leaky and/or shorted LED current/voltage characteristics. Most of the time, a crack in the ceramic substrate onto which the LED chip was soldered can be observed in addition to the LED chip crack. Both cracks are in the same direction and in line, meaning if the crack in the ceramic substrate was extended, it would look as though the crack continues to the LED chip. This is a good indication that the cracks in the LED chips were induced by cracks in the underlying ceramic substrate. Figure 4 shows an example LED exhibiting this trend.

Figure 4: Crack observed on ceramic-based multichip LED in same direction as ceramic substrate crack

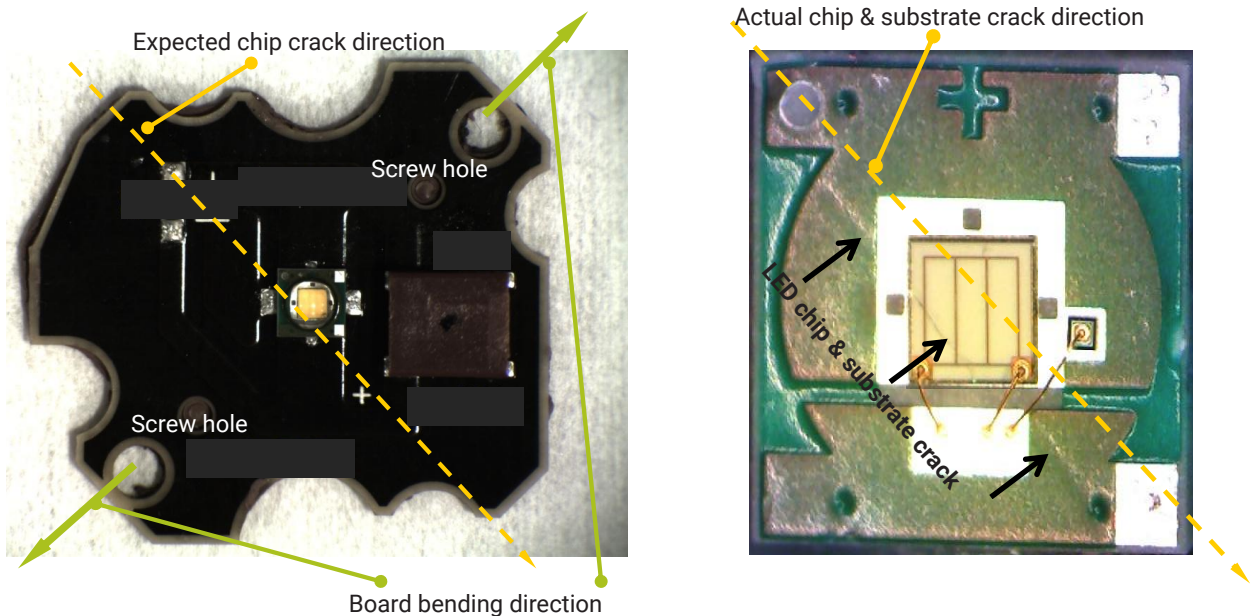
Another trend observed from the LED chip cracks was that, for assemblies that used an even number of screws, the direction of the cracks was always perpendicular to the axis of the screw locations. Figure 5 shows a damaged LED chip that was removed from an LED luminaire. The LED board was attached with two screws.

Figure 5: LED crack perpendicular to the stress direction. Image on the right is a close-up view of the PCB on the left.

1. Do not overtighten the screws when attaching an LED board to a heat sink.
2. Always use automated torquing and tightening of the screws with set torque force.
